Test Report No:	TJ3372	Date:	January 28, 2016
------------------------	---------------	--------------	-------------------------

SUBJECT: Evaluation of concrete sealer to assess the impact of the freeze/thaw weathering stress on the concrete fabric within the specimens utilizing petrographic analysis in accordance with ASTM C856.

PRODUCT EVALUATED: Client refers to samples received as “**SingleSeal**”. This project was entered into our receiving system on 7/2/15 in good condition.

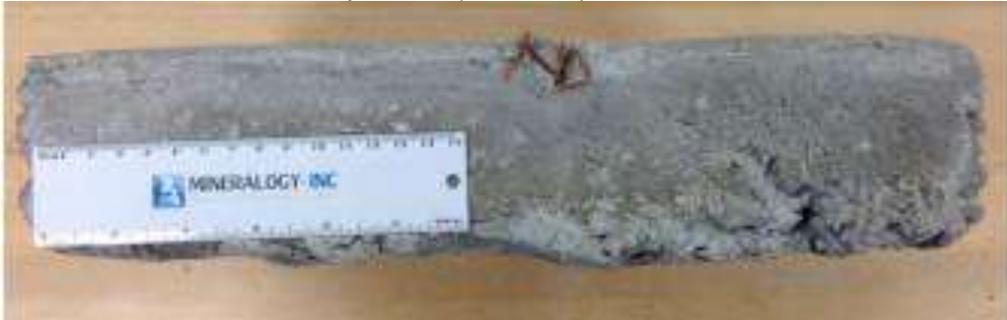
Control Specimen (Untreated) – Macro Picture

The distribution of the micro-cracks on the surface of the treated sample resembles mud-cracks on a tidal flat (red arrows).

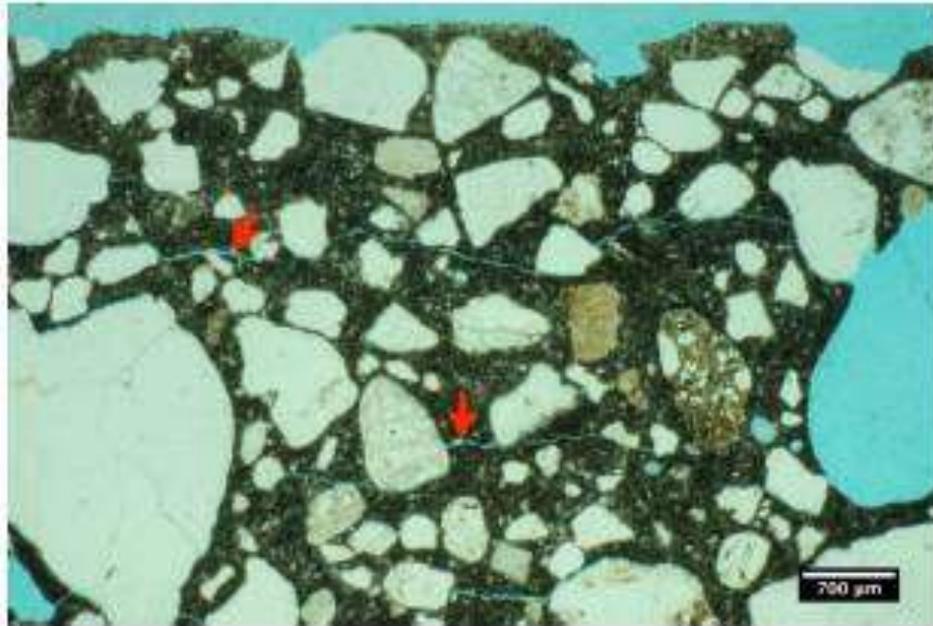
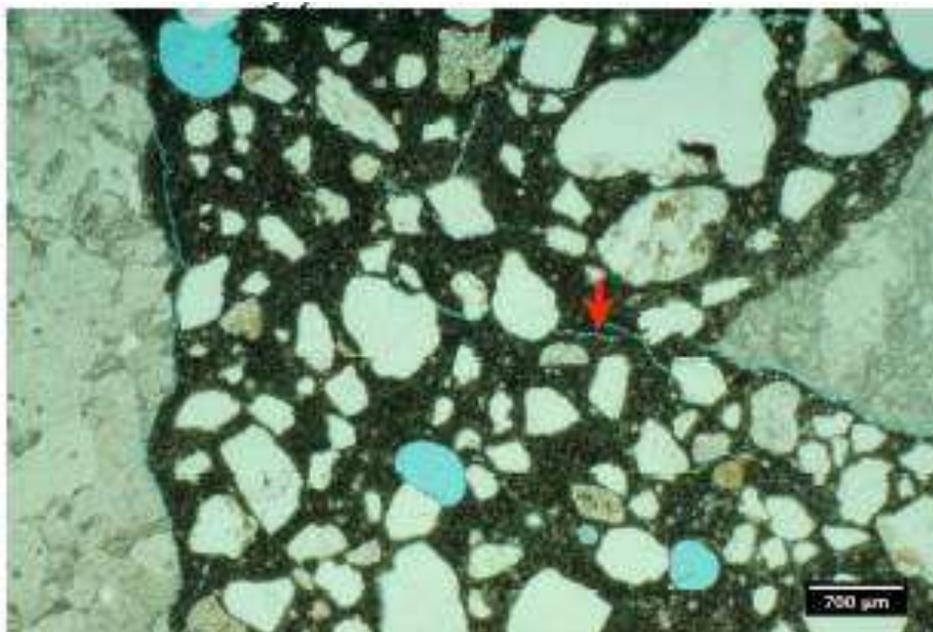
Test Specimen (Treated) – Petrographic Thin Section

*Fracture stain (blue: red arrows) is attributed to cyclic exposure of the slab to freeze/thaw weathering

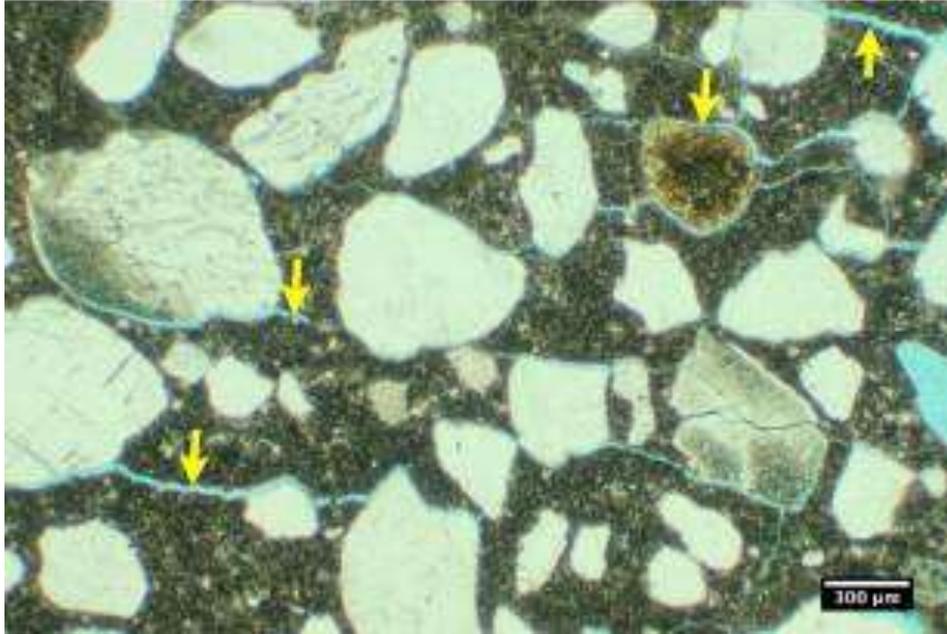
Test Specimen (Treated) – Petrographic Thin Section (Continued)

The paste constituents are densely interlocked and well lithified, contributing to the growth of fracture strain sub-parallel to the slab surface (yellow arrows).

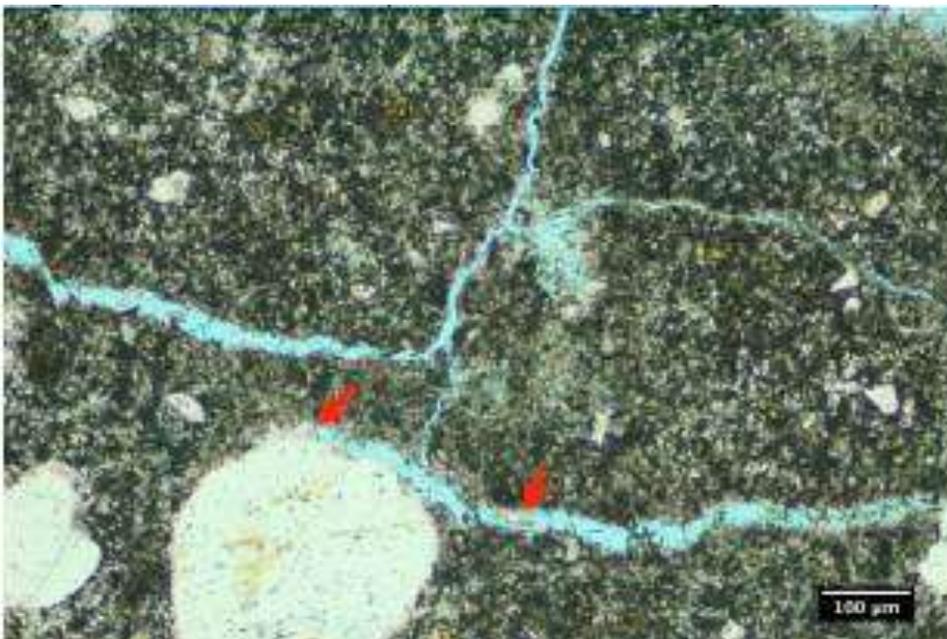
The fractures locally contain traces of authigenic calcite (red arrows) & ettringite

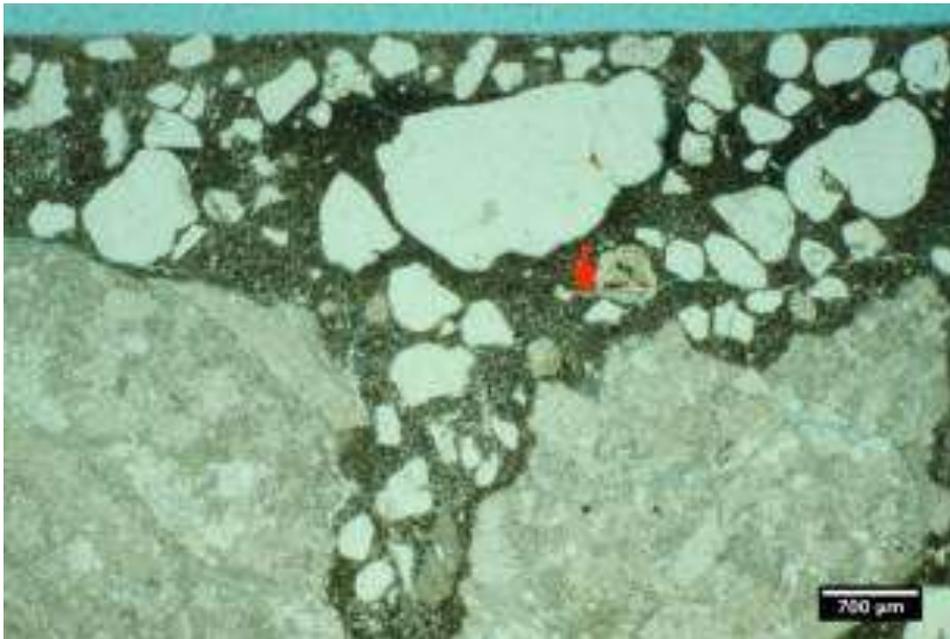
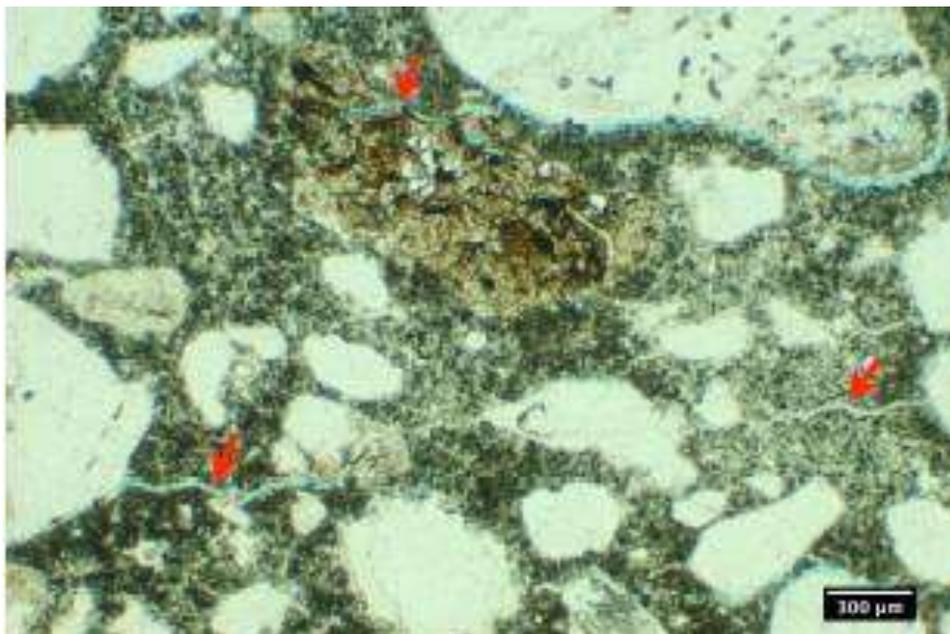
Control Specimen (Untreated) – Petrographic Thin Section

The matrix within the control specimen exhibits a dispersed, braided network of microfractures that have weakened the cohesive integrity (red arrows).

The relatively uneven & irregular hydration of the cement paste materials in the control specimen has contributed to the occurrence and distribution of randomly oriented, dispersed microfractures within the cement groundmass of this sample. In contrast, the test specimen exhibits a localized fracture strain that is concentrated along meandering sub-horizontal planes that are stacked within the concrete cross section. The dispersed geometry of the fracture strain within the control specimen is attributed to the (relative) heterogeneity of the paste materials.

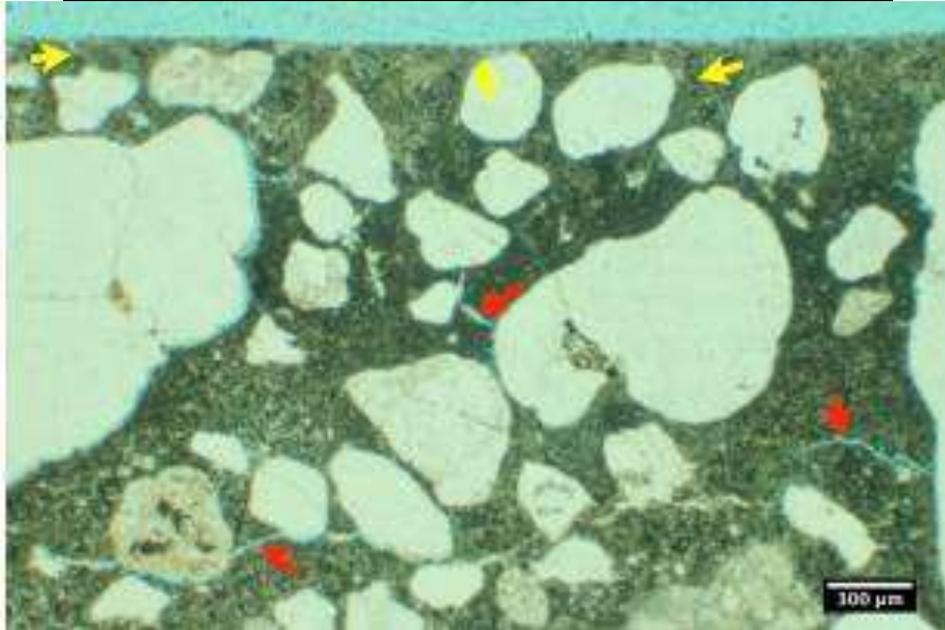
Control Specimen (Untreated) – Petrographic Thin Section (Continued)

The dispersed geometry of the microfracture network in the un-treated slab has contributed to locally significant weakening of the cohesive integrity (red arrows).

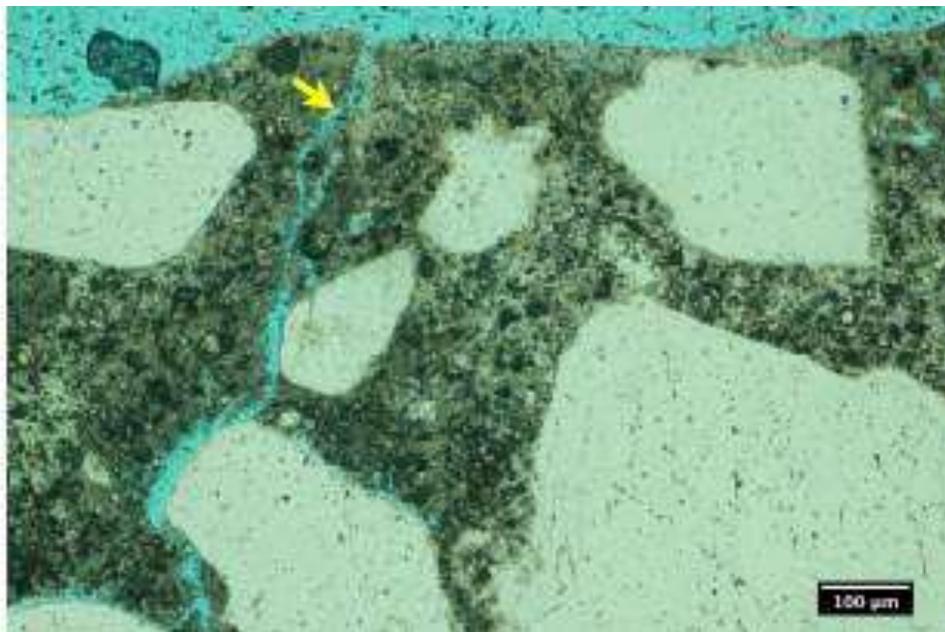
The exposure surface is intersected by an abundance of microfractures (yellow arrows) that expose the framework to H₂O absorption & increased expansive strain.

- The density of fracture strain intersections of the exposure surface of the test specimen (treated with Single Seal) appears nominal relative to the control specimen (untreated). These fracture strain intersections found in the control specimen (untreated) are likely to contribute to the influx of surface water during thaw cycles, thereby promoting further expansive strain and weakening of the concrete.

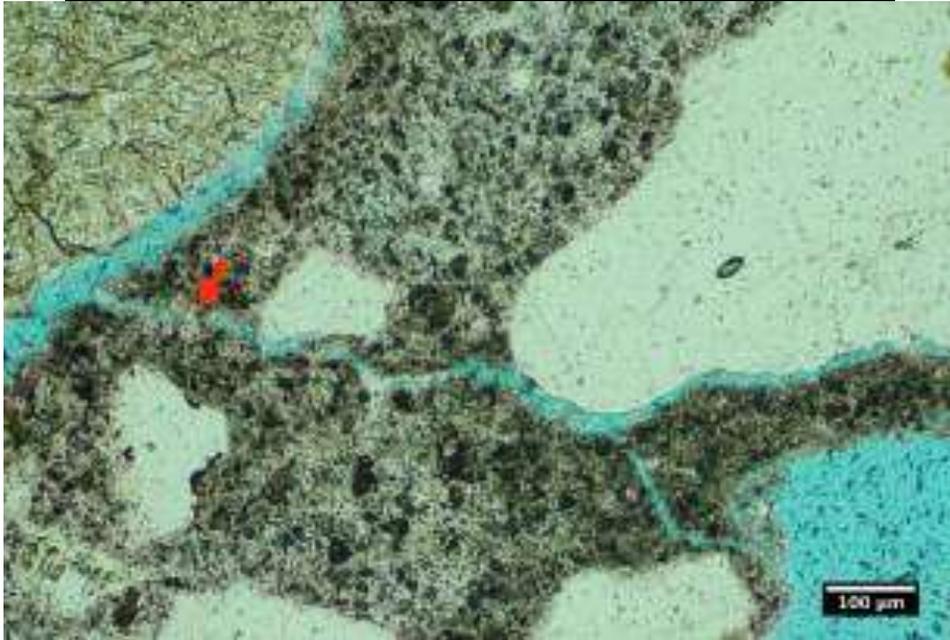
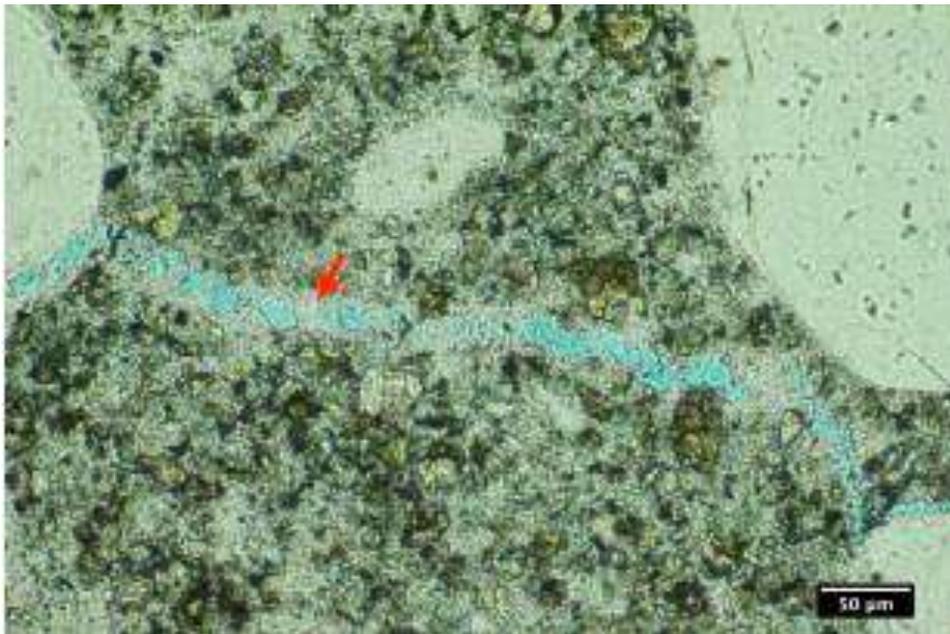
Control Specimen (Untreated) – Petrographic Thin Section (Continued)

Fracture-bridging calcite cement (red arrows). Note the diffuse & microporous character of the cement paste.

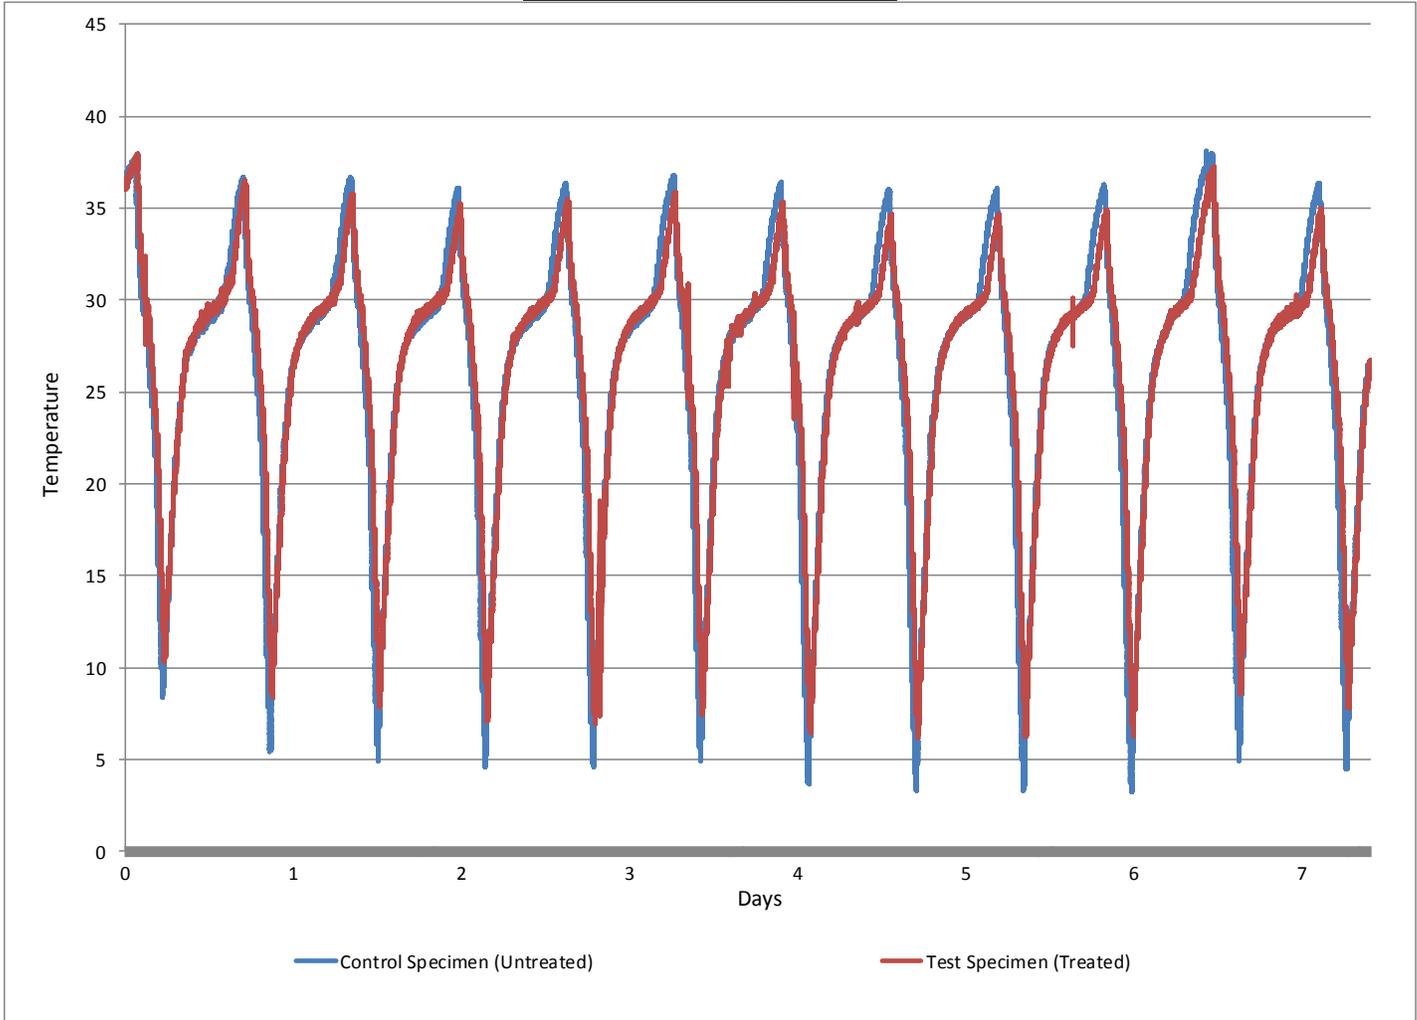
1" Thermocouple Temperatures

Test specimen has a more consistent internal temperature when compared to the control specimen. The test specimen also demonstrated an average minimum temperature of 4.2°F warmer than the control specimen and

- The test specimen (treated with SingleSeal) exhibited strong water retention, which allows for a more consistent internal temperature that is an integral part of the curing process.

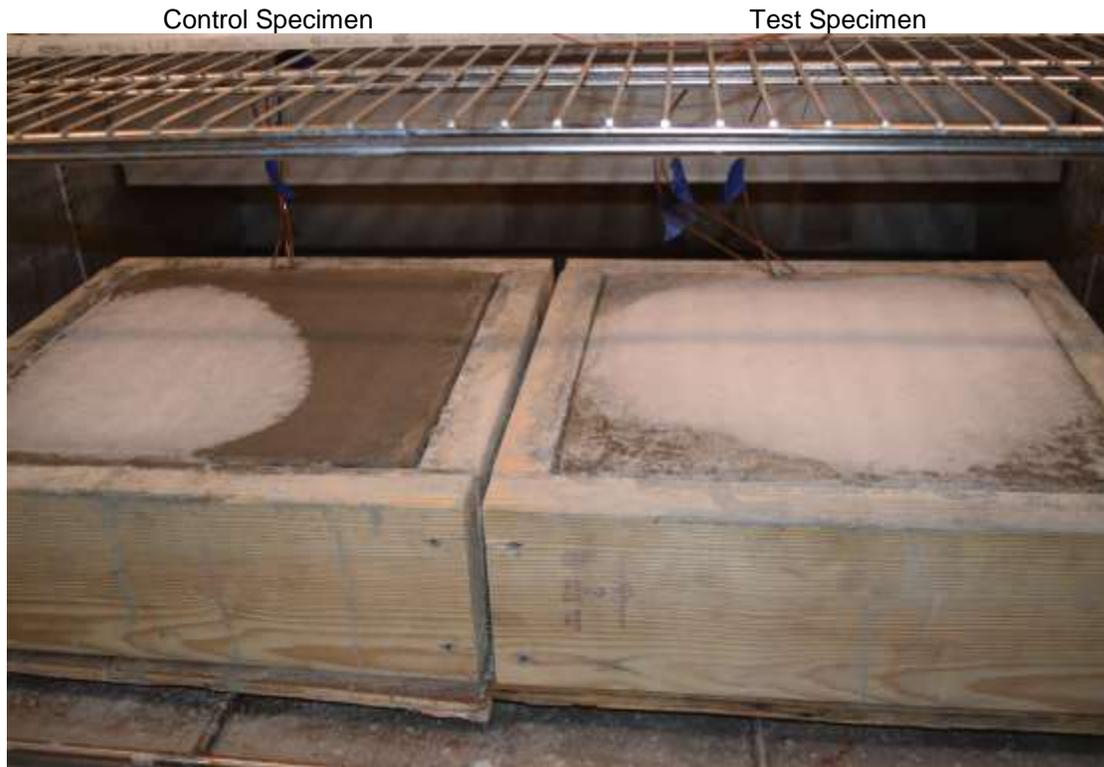
*The test specimen has evidence of ice and frost on the surface while the control specimen has absorbed the moisture.

- Throughout the testing process the test specimen (treated with SingleSeal) showed hydrophobic moisture control properties that were not found in the control specimen (see Appendix 3 pictures).
